MARINE INVESTIGATION REPORT

M00W0005

STRIKING OF A BRIDGE

THE TUGBOAT "SEA CAP XII" AND THE BARGE "T.L. SHARPE"

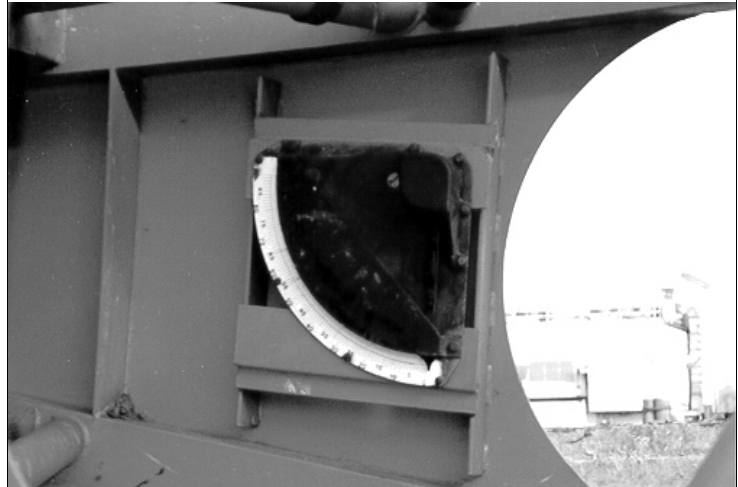
An inclinometer was affixed to the crane's arm.

Neither the skipper nor the deck-hand looked at the inclinometer on the crane's boom, nor did they inquire about the height of the boom's head. In the past, when passing under the bridges, the skipper's main concern was the height of the raised spuds; with the spuds vertical, the skipper could use the marks (in feet) imprinted on them to assess the height of other vertical protrusions. On this particular occasion, as the spuds were stowed, almost horizontal, in their brackets, their height did not cause any concern, and the skipper was not able to use them to estimate the height of the boom.

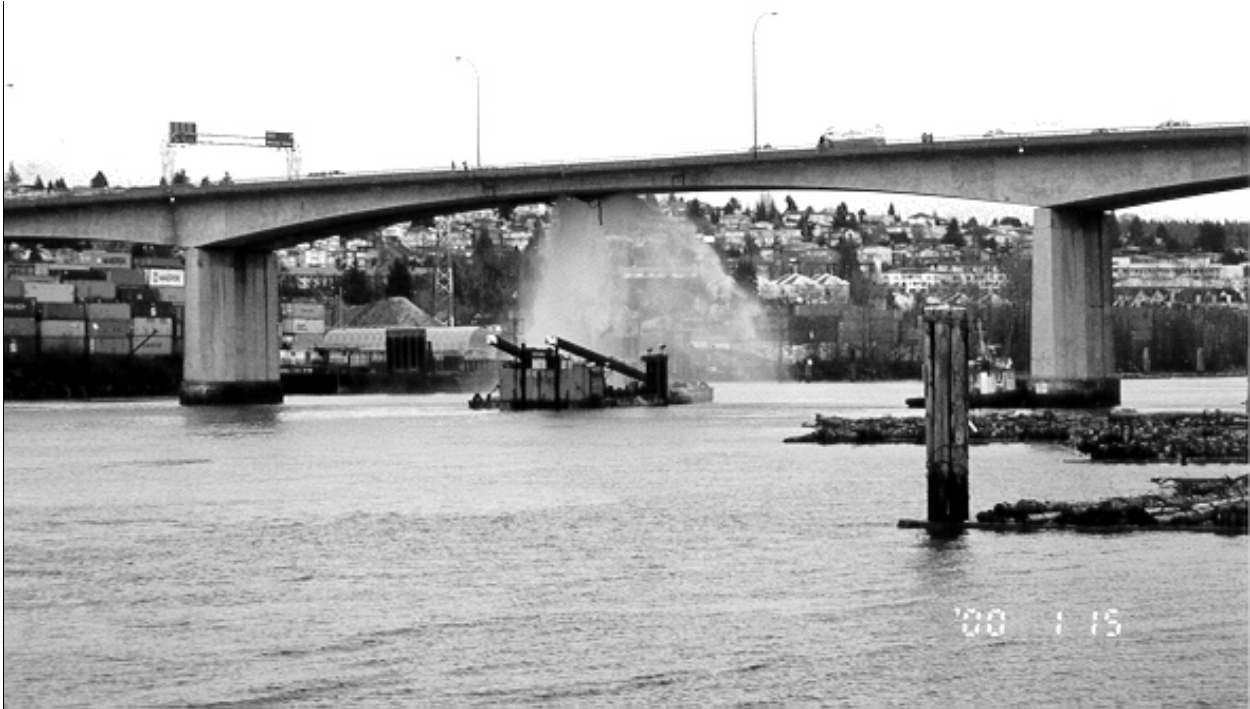
The Knight Street Bridge South seen from the west immediately after the occurrence. The barge "T.L. SHARPE" with spuds in the cradle and pointing forward is "anchored" under the bridge by the sunken crane astern. Water is escaping from the broken pipe.

The police stopped all vehicle traffic on the bridge while the authorities inspected the span and assessed the damage to the bridge deck and the two pipes underneath. The water pipe had been split open, allowing the water to spill. The gas pipe did not sustain any significant damage; however, it was moved out of its saddle and several support brackets of the pipe were bent slightly. The anchor bolts for the girder guides on the north end of the southbound drop-in span had been sheared and the lower plate moved about 6 cm to the west.

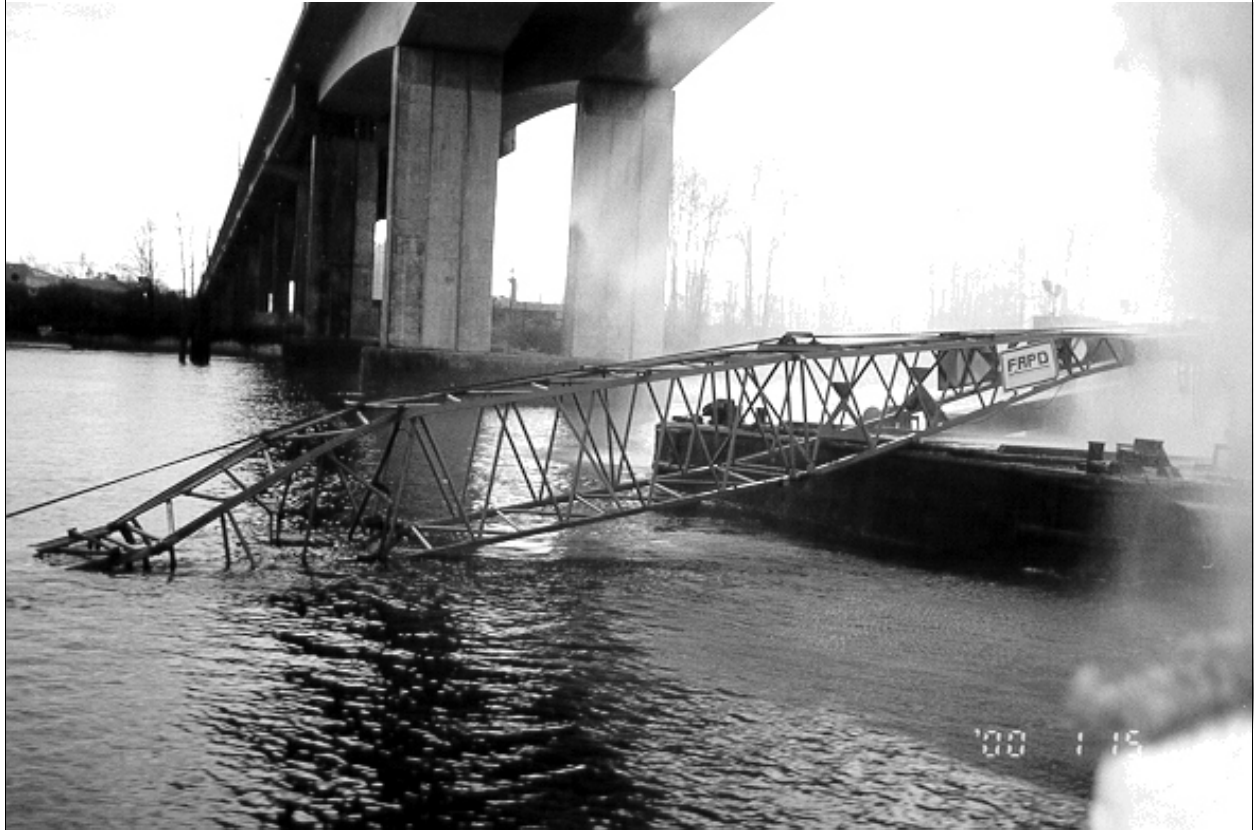
The crane moved off the barge's deck and sank under the bridge with its boom, bent during the striking, extending above the surface.

The investigation established that the sheave on top of the boom first hit the side of the eastern concrete girder slightly above the highest point of the arch, whereupon it slid under the girder and hit the steel grate and the pipes. As a result of the striking, the boom was bent and twisted and the securing arrangements between the barge and the crane were severed. The crane's machinery was water-damaged as a result of the subsequent sinking.
